NASA TM X- 62,428

THE EFFECT OF A PLANETARY SURFACE PENETRATOR ON THE SOIL COLUMN  
SURROUNDING THE IMPACTING BODY

ABSTRACT

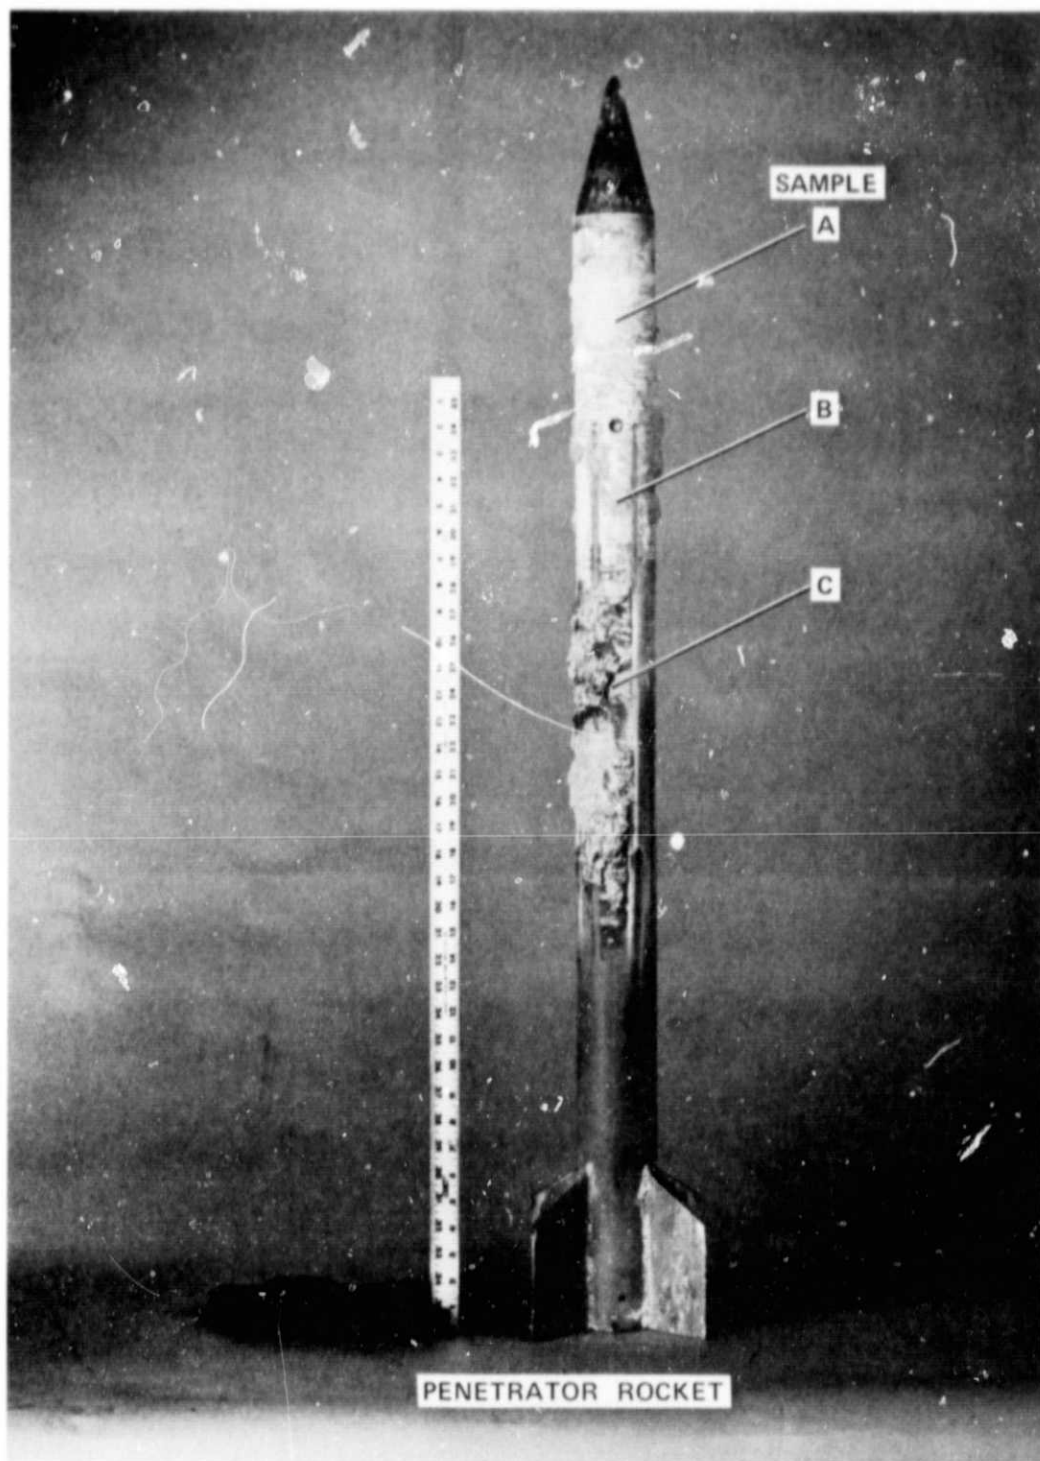
Soil samples immediately adjacent to the penetrator casing were carefully removed from several sites, as shown in figure 1. Selected fragments of paint and casing material were also removed for examination. Optical microscopic examination of the soil samples showed that much of the soil surface adjacent to the casing was coated with red paint (fig. 2). The paint came from the outer surface of the penetrator casing. Not so apparent was a white paint covering parts of the soil surface as well as part of the red paint. The white paint was evidently a primer placed directly over the metal of the penetrator casing before the red paint was added. The soil surface in direct contact with the casing was very smooth and striated. The paint had been smeared in parallel streaks that were thicker in some places than others. The larger soil grains were usually not fractured by impact. Instead, they appeared to be pushed back into the softer matrix material. Some shiny particles of abraded metal could be seen adhering to larger soil grains. The metallic particles represent portions of casing metal that had been scoured off as the impactor penetrated the soil column. Figure 2 shows a surface where paint has built up over the soil and some metal has scraped off the casing.

Figure 1.— Penetrator casing after impacting into dry lake bed. Samples of soil were removed from penetrator surface at locations A, B, and C for analyses. Also, material was scraped from the penetrator casing to compare with the samples.

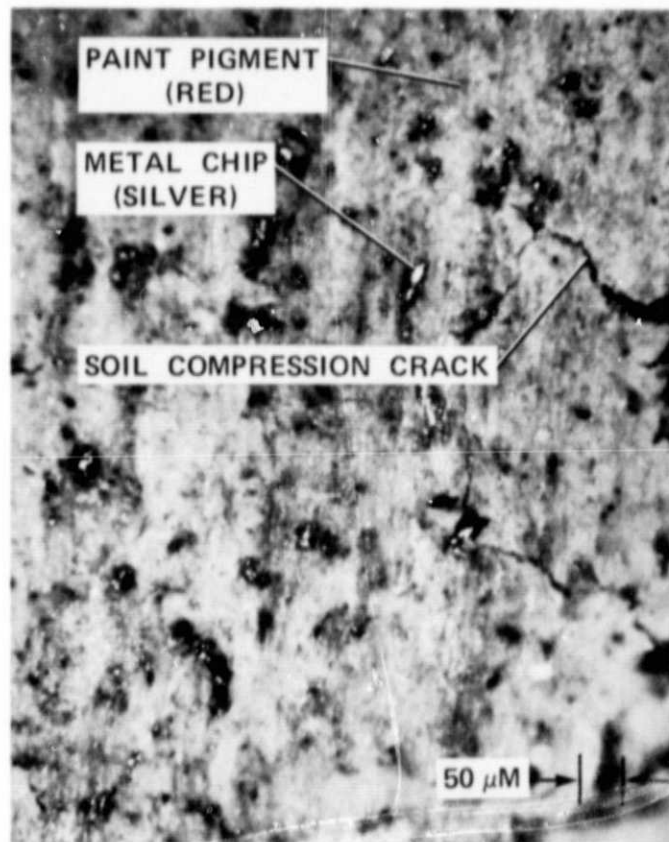
Figure 2.— Photomicrograph of soil immediately adjacent to the penetrator's casing. The red and white streaks are paint from the penetrator's outer coating. The metal chips are pieces of metal from the nose cone and casing body that were scraped off during impact (230X).

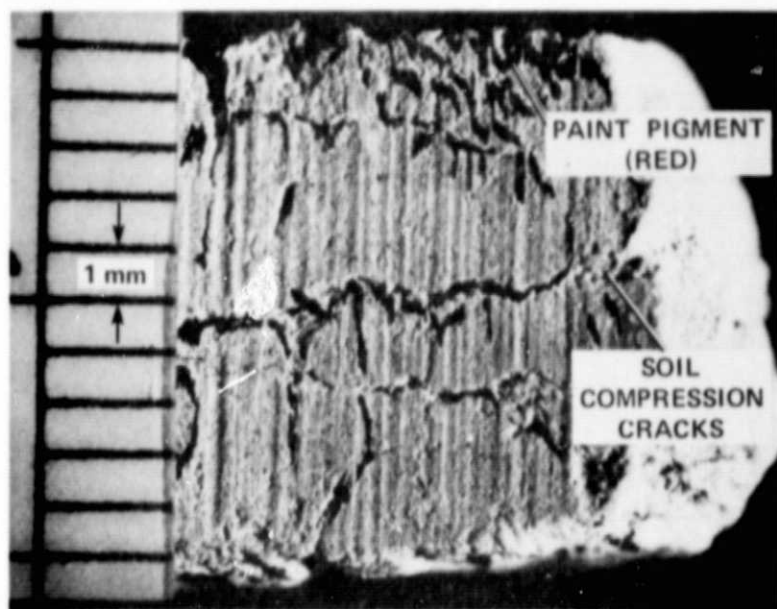
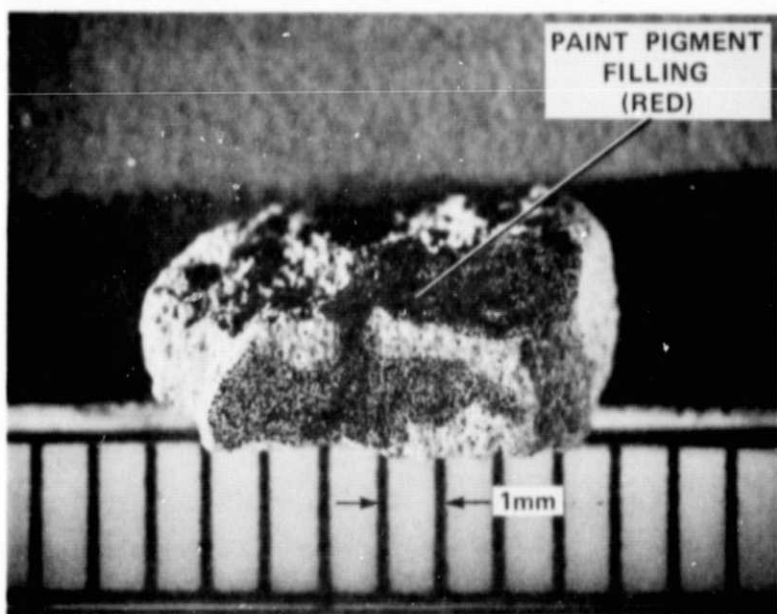
Cracks in the soil ~~perpendicular~~ perpendicular to the penetrator's entry axis were common. These cracks are caused by the rebounding soil after the compression wave formed during the penetrator's entry into the soil. Frequently the paint pigment (figs. 3(a) and (b)) migrated into these cracks where it coated and/or completely filled them. Thus, the paint pigment appears to be mobile during the penetration: it smears off the penetrator's metal casing and coats

Figure 3.— Photomacrograph of the soil immediately adjacent to the penetrator's casing showing the cracks caused by the rebounding soil after the compression wave formed during the penetrator's entry into the soil. During the time of formation, these cracks were filled by the mobile point pigment which came from the protective coating on the exterior of the penetrator's casing. View A is looking directly at the face between the casing and soil boundary. View B shows paint that migrated into a crack.

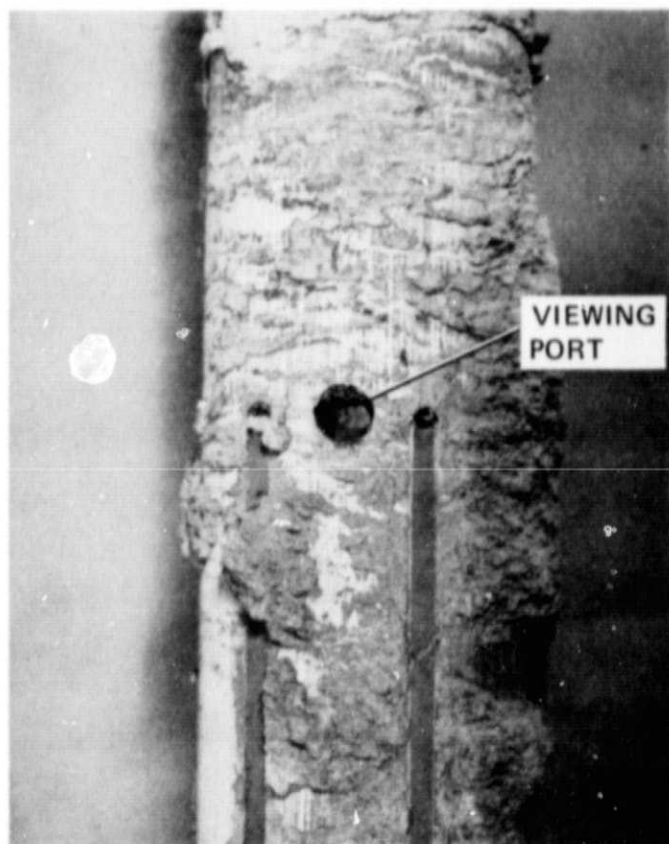
the adjacent soil surface as it passes through the soil column. The smeared paint pigment has also partially covered one viewing port on the side of the impactor, as shown in figure 4. The port was set back from the skin line, thus allowing the abraded debris to build up. Occasionally, portions of smeared paint show a vesicular texture (fig. 5). This texture indicates sufficient heat was generated during penetration to melt the paint.

Figure 4.— Photo of penetrator casing showing the buildup of debris smeared over the viewing port.

This study suggests that great care be taken in the use of coating materials and the metal alloys selected for the penetrator's exterior casing. Otherwise, the accuracy of any experiment requiring an uncontaminated *in situ*

sample will be seriously affected. Future design and testing of penetrator configurations should be accompanied by careful analytical studies. The studies should include both the penetrator casing surface and the soil attached to the casing.

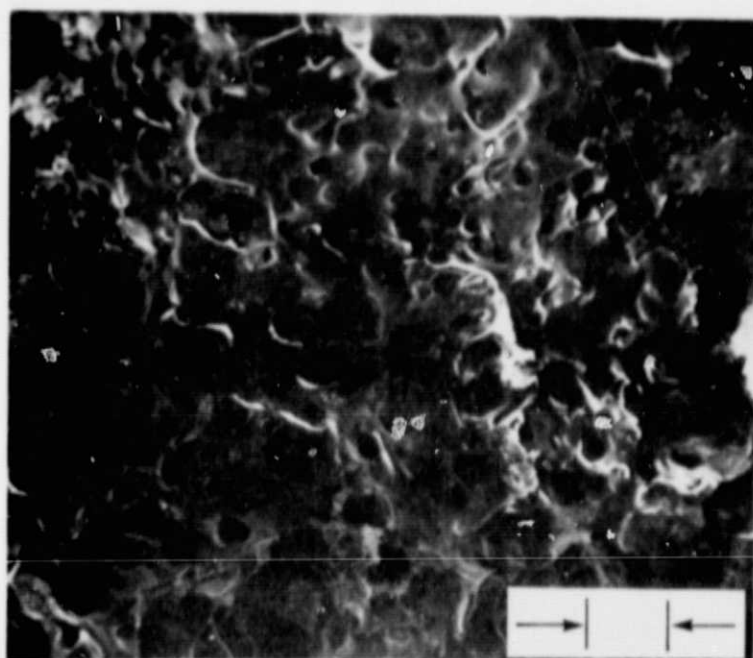
Figure 5.— Scanning electron microscope image of the vesicular texture produced by the melted paint coating the viewing port (100X).

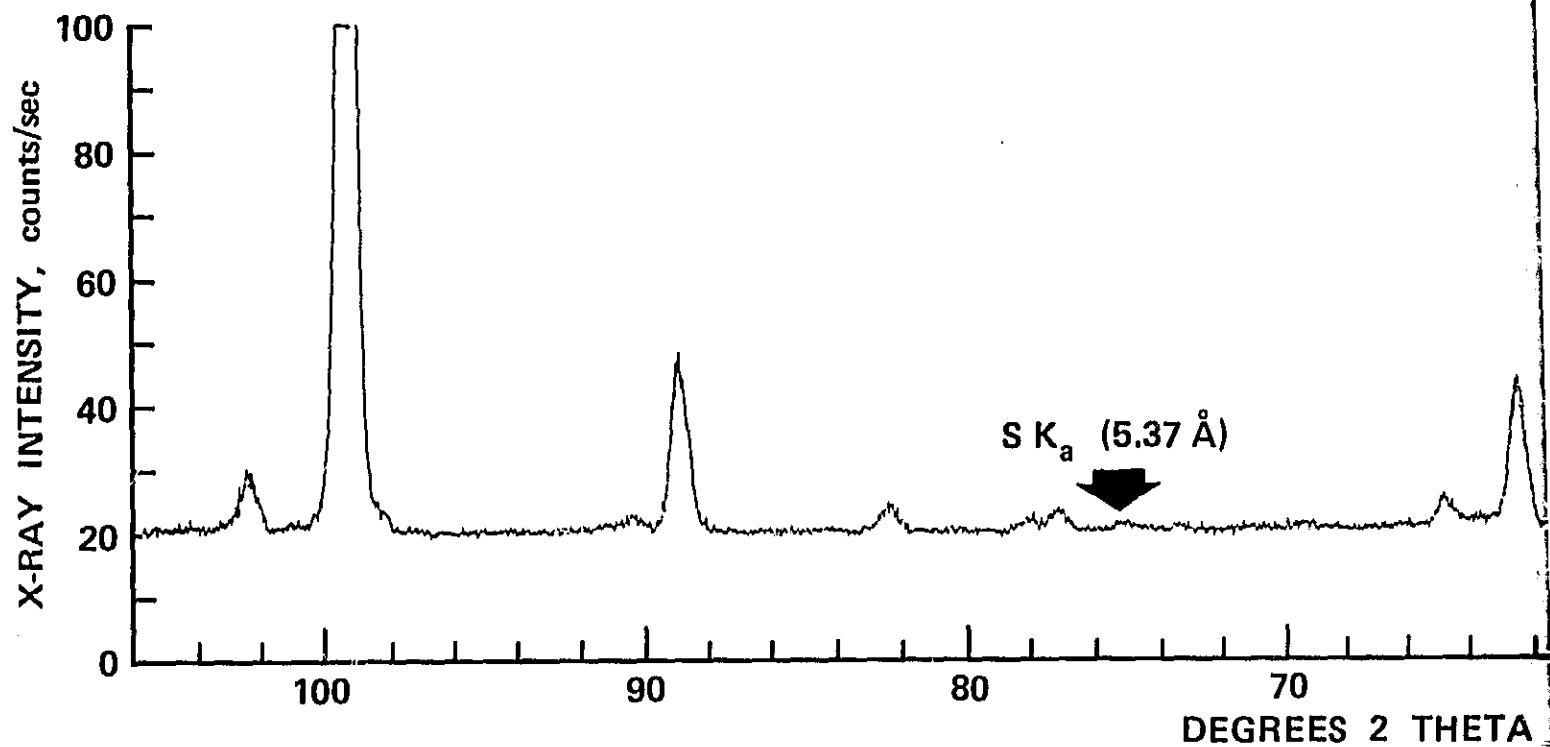
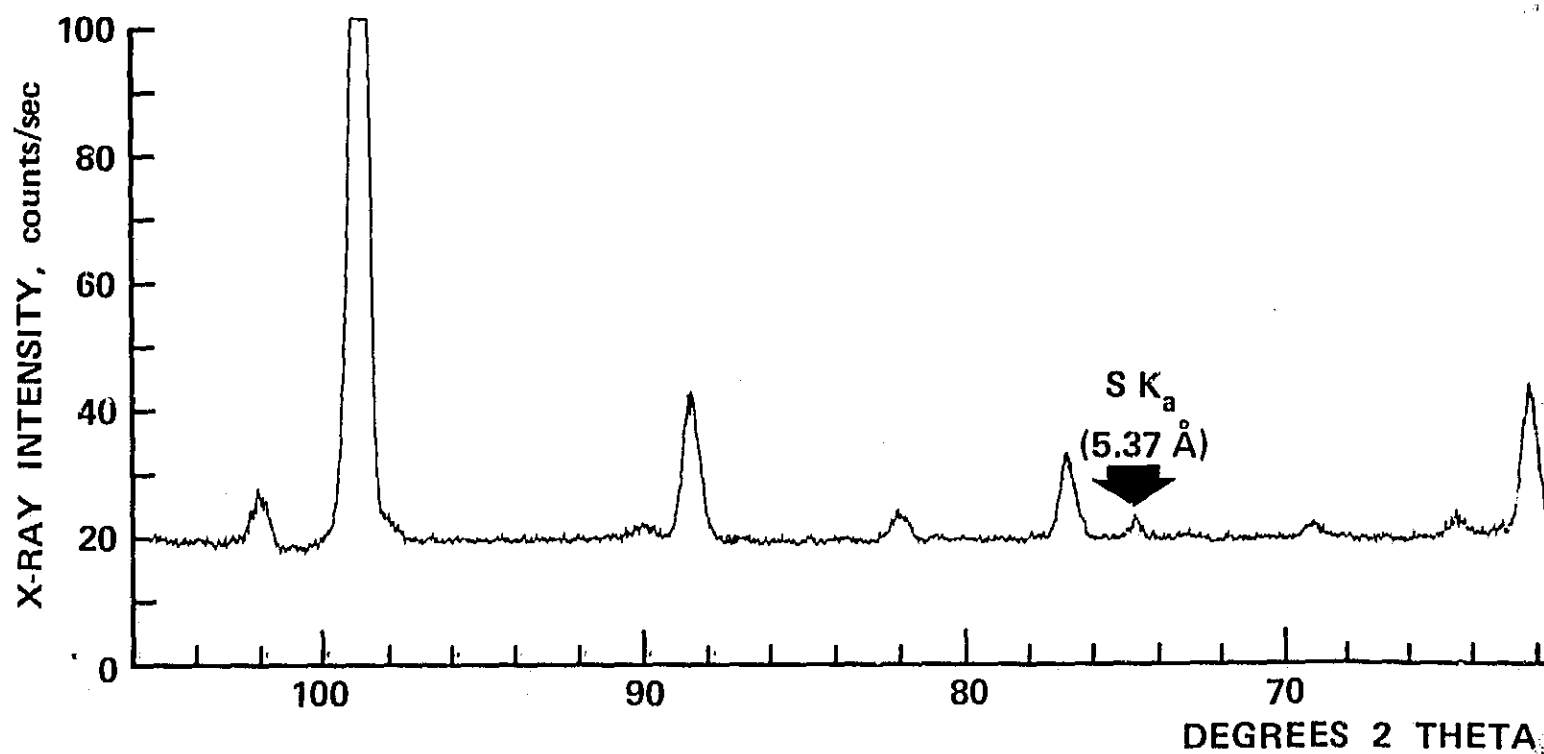
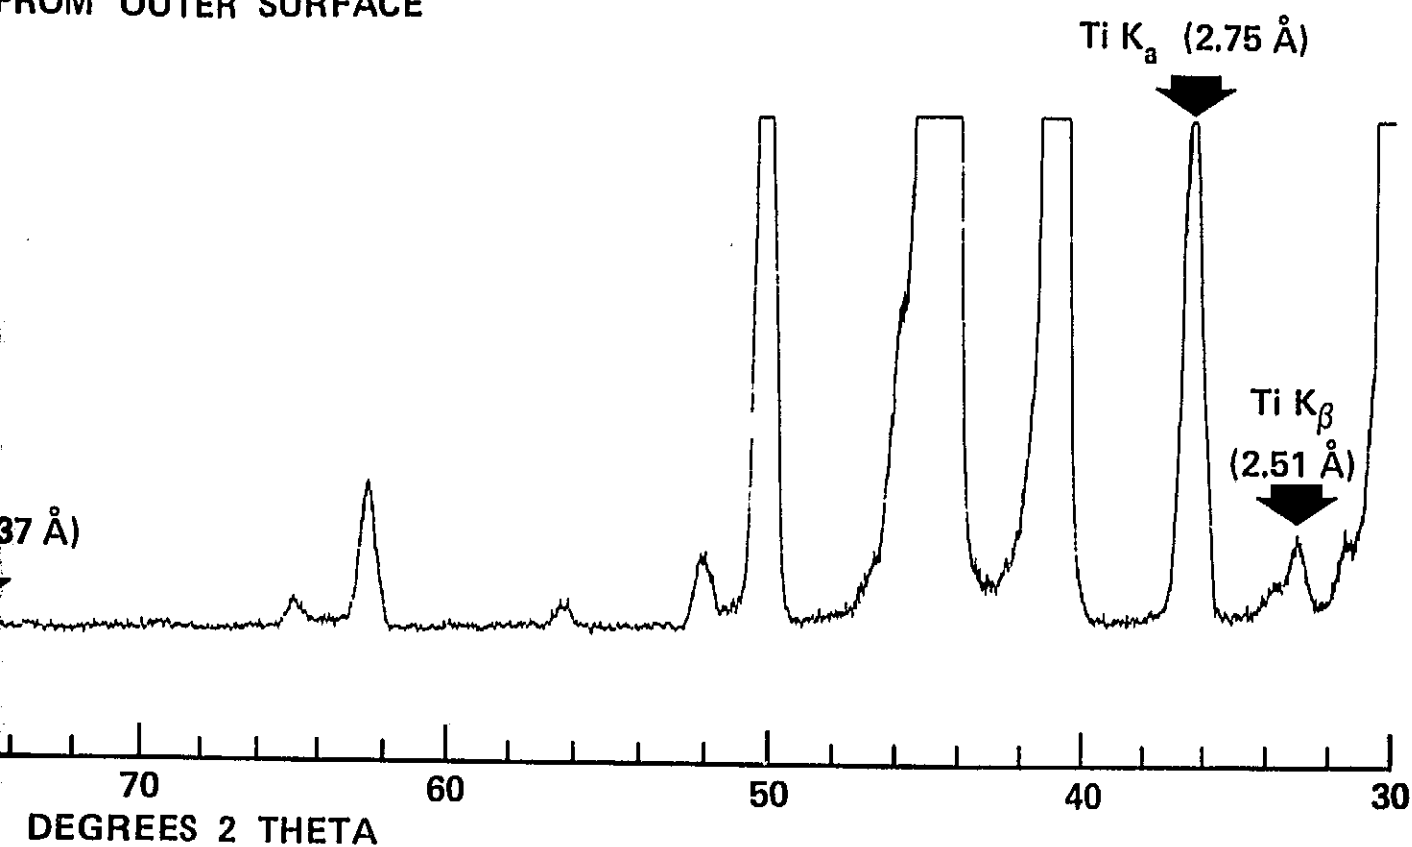
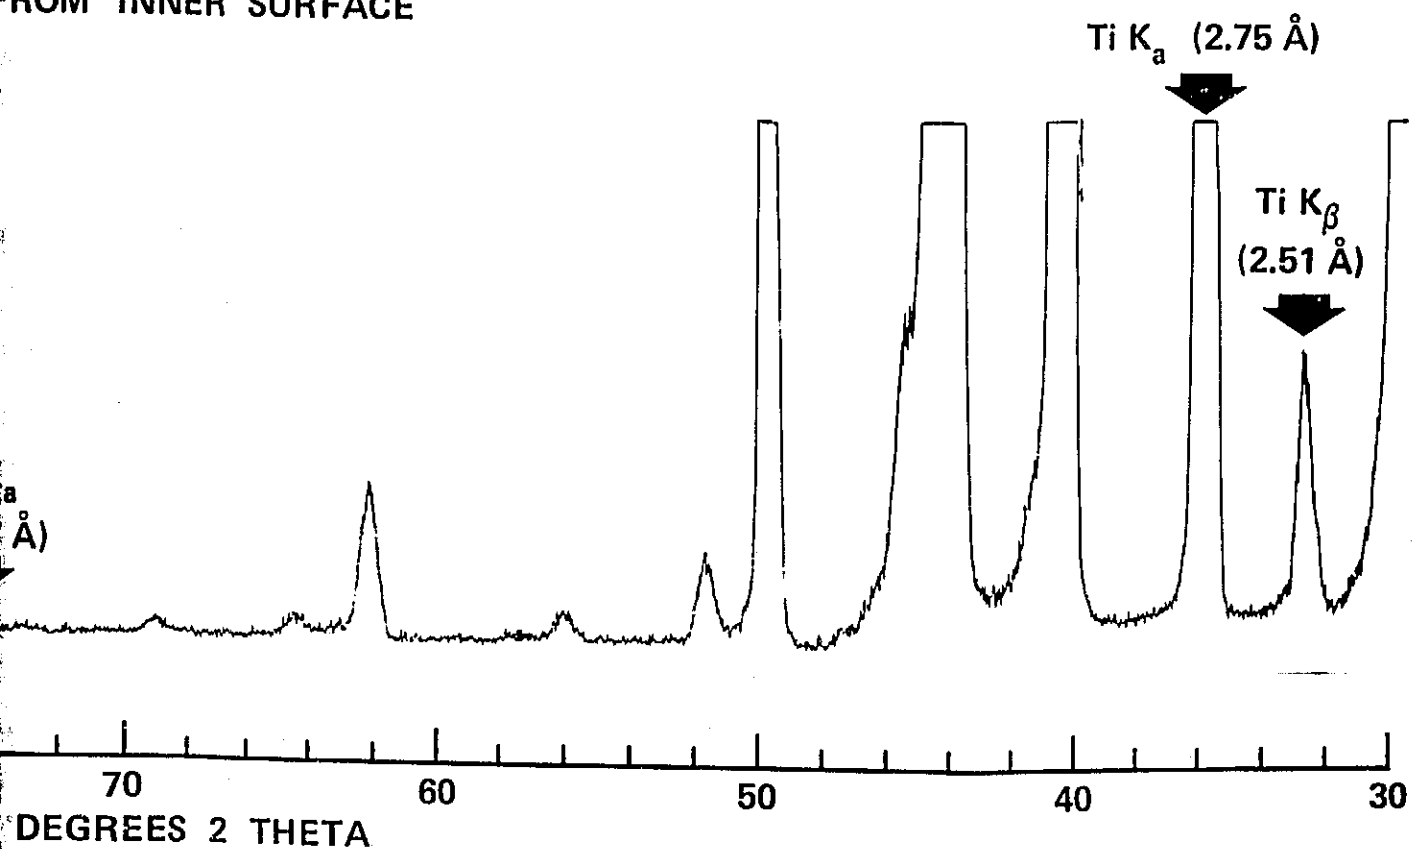
Figure 8.— Portion of strip chart from X-ray fluorescence analysis showing the increased concentration of S and Ti for the bulk soil samples tested.
